**Flood Control Project Maintenance
Levee Inspections**
LMA District Cover Sheet
Spring 2017 Levee Inspection Results

Sacramento Maintenance Yard Willow Slough Bypass

Spring 2017 Levee Inspection Results

Waterway			Bank	Unit Miles
Unit No. 01 Willow Slough Bypass or North Levee			Left	5.05
	Spring (March - May)	Summer (June - August)	(September - November) Fall	Winter (December - February)
Unit Maintenance Rating (Fall Only)				
Date of Inspection	4/18/2017 - 4/18/2017			
DWR Inspector	Zach Jojola			
Accompanied By	Casey Lund

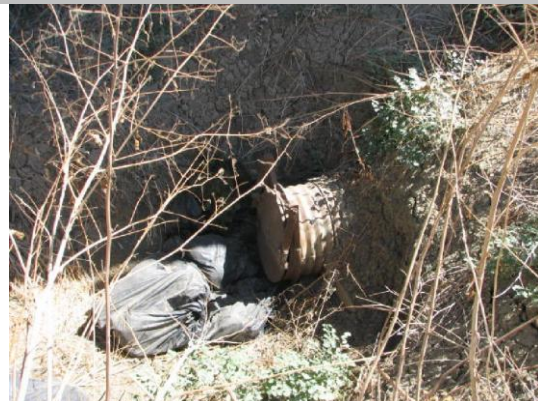
Photo 1 of 3 : UCIP_SP_2017_45285_22809.jpg

Comment Code					
Inspector Comment					
FS_ID:45285 DS_ID:546 EP_NO: 10319 Repair Type: Non-Urgent Crossing Status: Found UCIP Comments: 04/12/2017 WS & LS - good/clear, inspected by JK, RF. (DWR Sacramento Yard - C. Lund) 05/24/2013 Material removed from inlet last fall. Outlet cleared. (DWR Sacramento Yard - C. Lund) 09/20/2012 Soil and debris on inlet mouth. (DWR UCIP - P. Amatya) FIELD_STRUCT_DESC: 24-inch corrugated metal drainage pipe through the levee, 15 feet below the crown. Flap gate is located on the waterside (WS) end. (18-inch pipe authorized under Automatic Board Order (ABO) issued as Permit No. 10319, 1974 - Bell) [Additional Reference(s): DWR Levee Log, 1990. USACE Sacramento O&M Manual Unit 120, Willow Slough Channel Relocation and Levee Construction, February 1947, Drawing No. 50-4-2281 Sheet 4 (Station 244+47)] FS Date: 5/14/2015 1:36:11 PM

Waterside view- pipe and flap gate.

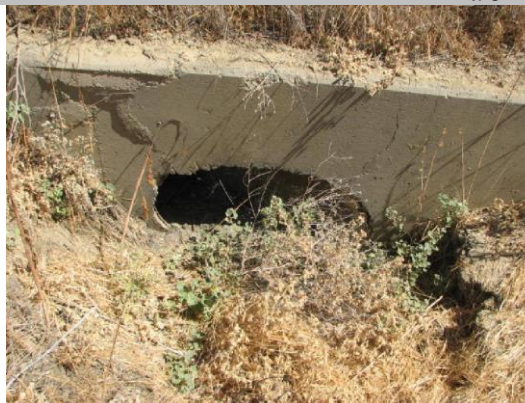
Photo 2 of 3 : UCIP_SP_2017_45285_22811.jpg

Comment Code						
Inspector Comment						
FS_ID:45285 DS_ID:546 EP_NO: 10319 Repair Type: Non-Urgent Crossing Status: Found UCIP Comments: 04/12/2017 WS & LS - good/clear, inspected by JK, RF. (DWR Sacramento Yard - C. Lund) 05/24/2013 Material removed from inlet last fall. Outlet cleared. (DWR Sacramento Yard - C. Lund) 09/20/2012 Soil and debris on inlet mouth. (DWR UCIP - P. Amatya) FIELD_STRUCT_DESC: 24-inch corrugated metal drainage pipe through the levee, 15 feet below the crown. Flap gate is located on the waterside (WS) end. (18-inch pipe authorized under Automatic Board Order (ABO) issued as Permit No. 10319, 1974 - Bell) [Additional Reference(s): DWR Levee Log, 1990. USACE Sacramento O&M Manual Unit 120, Willow Slough Channel Relocation and Levee Construction, February 1947, Drawing No. 50-4-2281 Sheet 4 (Station 244+47)] FS Date: 5/14/2015 1:36:11 PM

LM Start	4.59	Rating **	M	Issue No.	39 (cont)
LM End	4.59	Issue Type +	En	Location *	WS

Landside view- pipe and headwall.
